CIVIL AERONAUTICS BOARD

AIRCRAFT ACCIDENT REPORT

UNITED AIR LINES, INC.
BOEING 727, N7030U
SALT LAKE CITY, UTAH
NOVEMBER 11, 1965

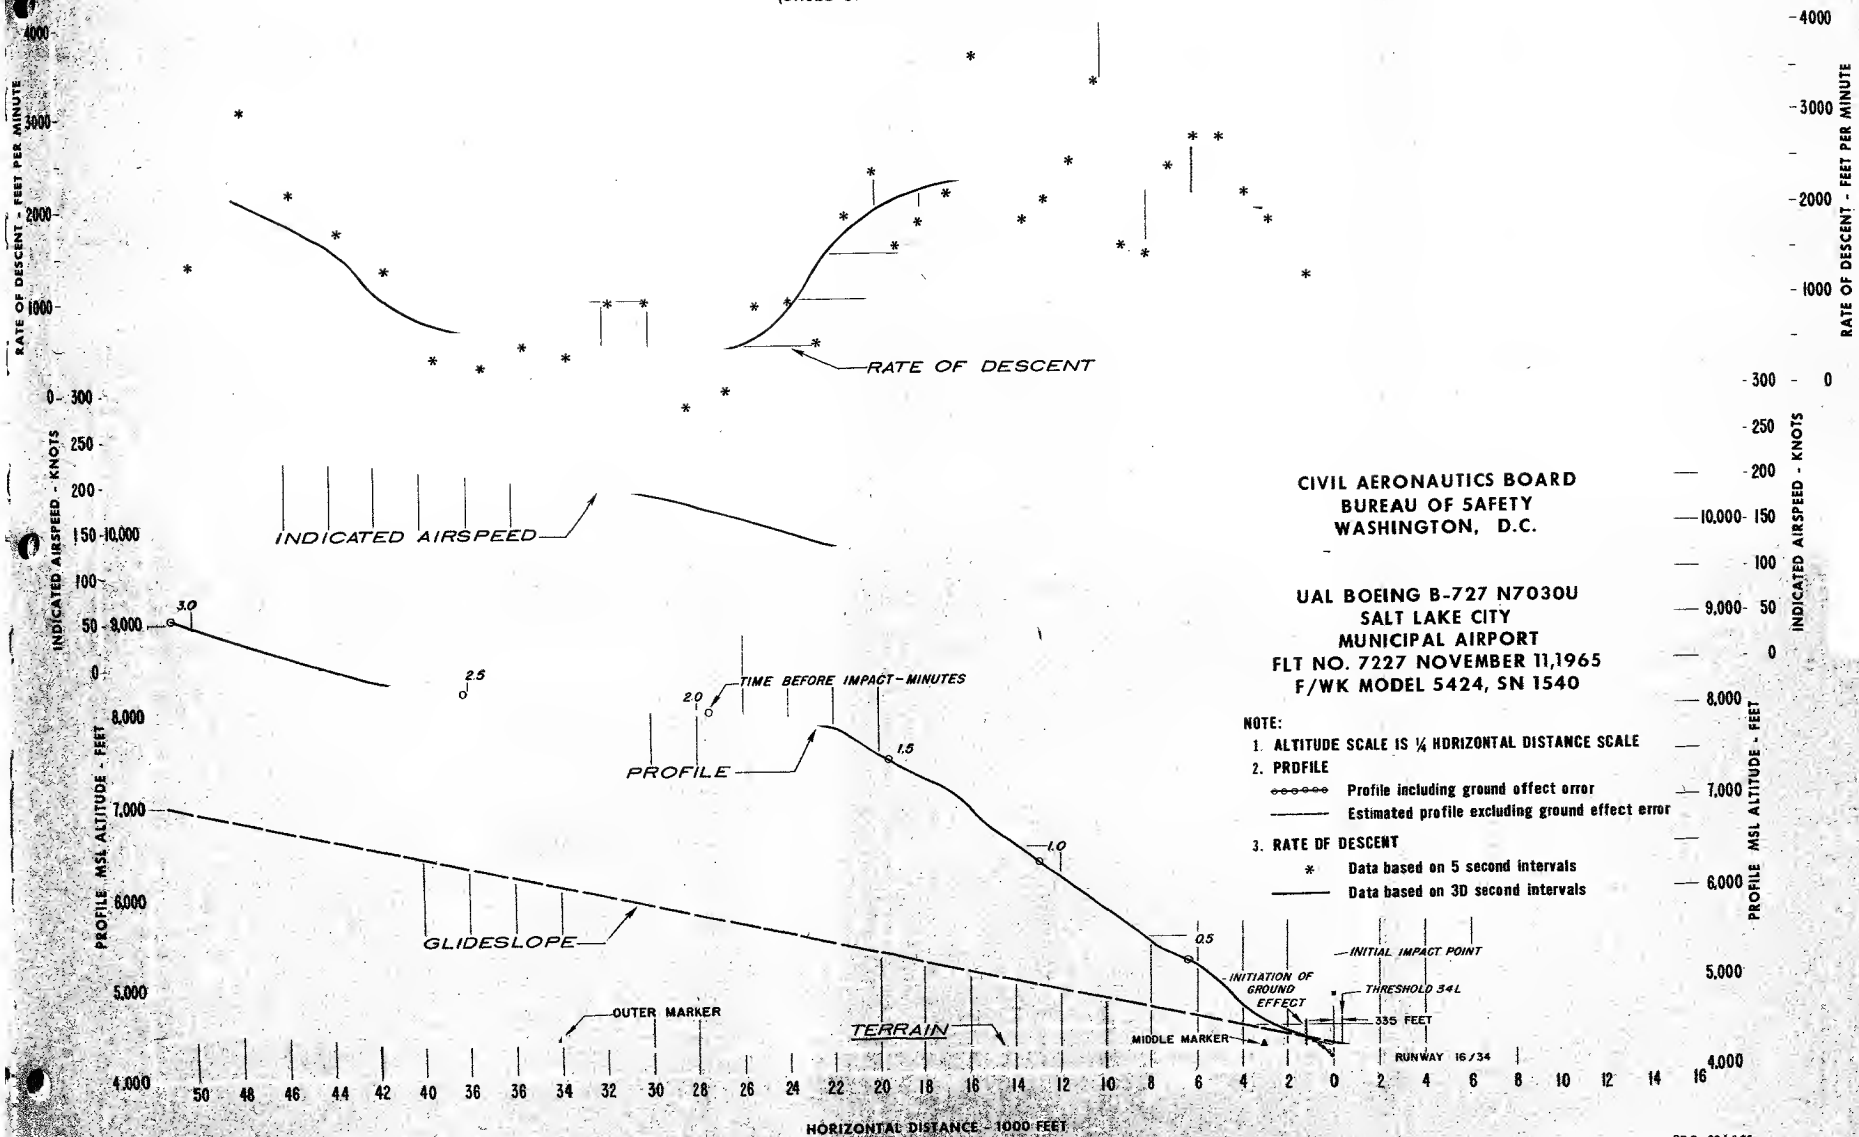
ATTACHMENT A

(BASED ON FLIGHT RECORDER DATA)
